Failure Analysis of an 8-inch Urban Gas Distribution Steel Pipeline

Mohammad Shayegani Akmal *, Amir Pasha and Azin Ahmadi

Metal Corrosion Research Group, Industrial Protection Research Department, Research Institute of Petroleum Industry, Tehran, Iran

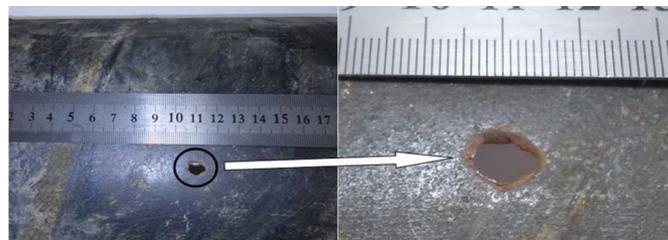
Figure 1 shows the hole created in the 8-inch tube. As can be seen, there are no corrosion effects on the external surface, and internal corrosion has been occurred. Figure 2 (a) shows the inner surface of the 8 inch pipe around the hole created. As can be seen, there are signs of localized corrosion, but only at one location, the hole has been created. In Figure 2 (b), the deposits formed on the inner surface of the pipe are shown. No significant tubercles were observed on the inner surface, especially in the lower position of the tube. The presence of such tubercles is an indication of the occurrence of microbial corrosion [7, 8].

Figure 1: The external surface of the 8-inch pipe, the pipe was perforated due to internal corrosion.

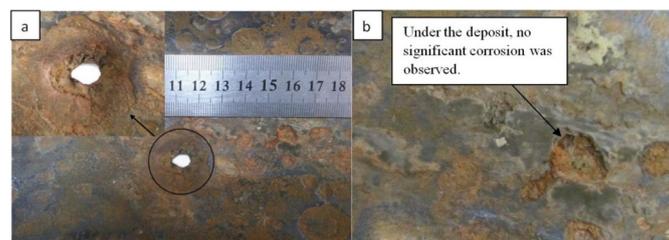
Figure 2: The internal surface of the 8-inch pipe (a) the hole formed and (b) no significant corrosion occurred under the deposit.

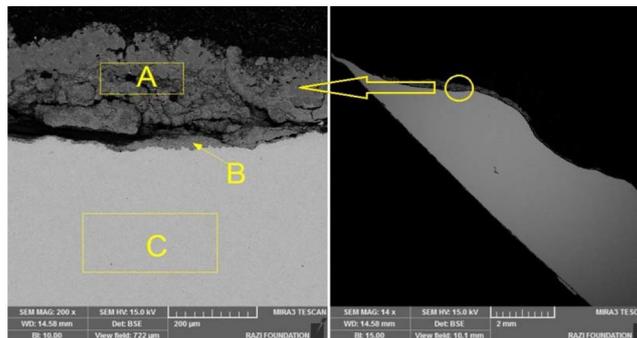
The results of the deposit analysis using the EDS analyzer are shown in Table 2, and the image of the points examined is shown in Figure 3.

failure of the 8-inch pipe was due to corrosion from the internal surface. Due to the fact that the chemical analysis of deposits on the inner surface of the pipe did not show significant amount of sulfur, and due to the absence of small and deep pits, the probability of failure due to microbial corrosion caused by SRB microorganisms is very weak. The presence of iron carbonate compounds in the deposit shows the most likely cause of the failure is CO₂ corrosion.

Table 2: Chemical analysis at different points shown in Fig. 3.

Element (Wt.%)	C	Al	O	S	Mn	Ca	Fe	Si
(Figure 3) A	17.63	0.25	39.89	2.51	0.24	0.33	38.77	0.38
(Figure 3) B	10.30	0.13	41.31	3.31	0.51	0.10	44.08	0.26
(Figure 3) C	5.89	0.18	2.21	0.19	0.57	0.06	90.61	0.29

Figure 3: SEM image of the hole cross-section and EDS analysis locations.
